SERVICE BULLETIN

No. 198

Piper Aircraft Corporation

SUBJECT: Replacement of Tail Brace Clevises

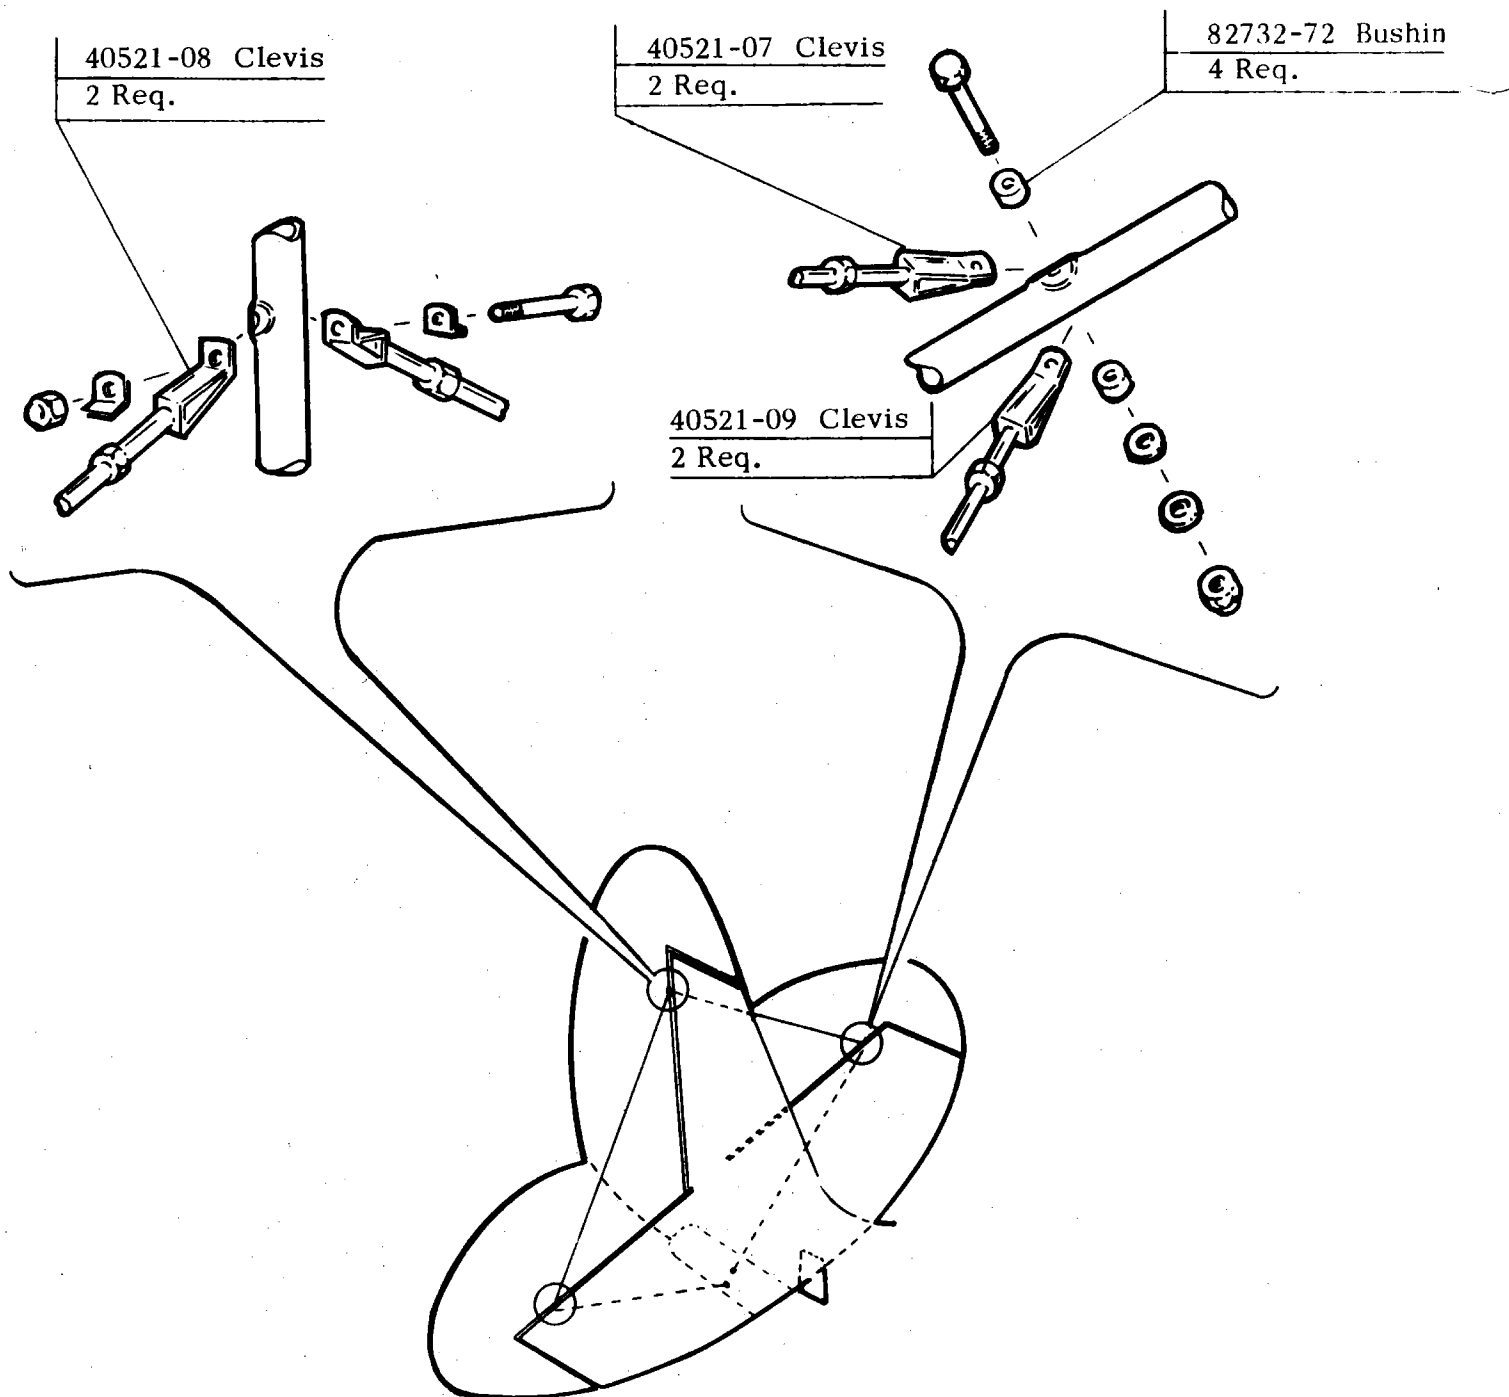
The tail brace clevises and bushings on the aircraft indicated by the above serial numbers are to be replaced.

The sketch on the reverse side of this Service Bulletin will indicate the location of the clevises and bushings to be changed.

Kit No. 754 381, consisting of six (6) clevises and four (4) bushings to comply with this Service Bulletin, will be forwarded by automatic factory distribution. The kit will be provided on a no charge basis. A compliance card is furnished with the kit for this modification. This card must be signed and immediately returned to the factory.
