SERVICE BULLETIN

Piper Aircraft Corporation

NUMBER 124

SUBJECT: PA-22 Landing Gear

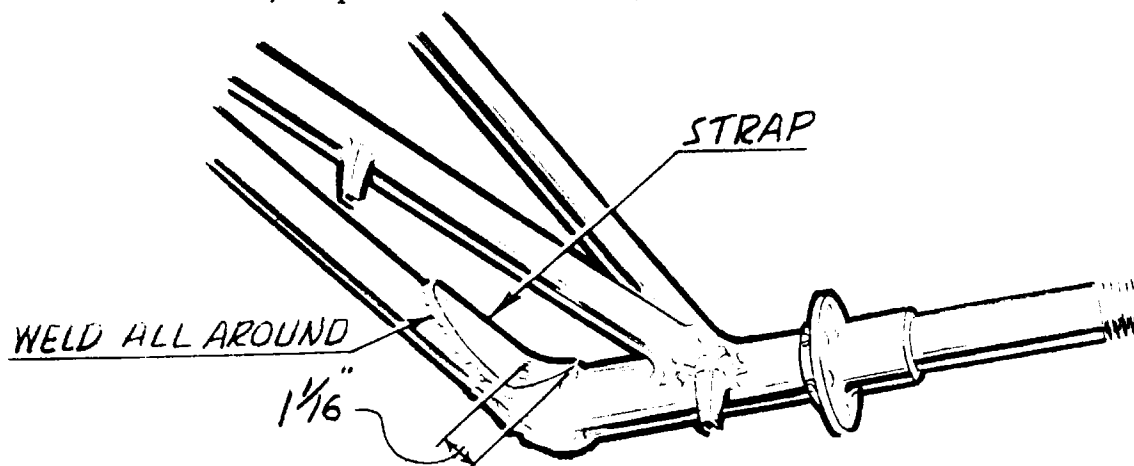
A number of field service reports have been received to the effect that cracks have been appearing in the leading edge of the streamlined tube of the PA-22 landing gears at a point where it joins the inboard end of the axle.

Indications are that this is a fatigue failure and it is requested that all Model PA-22 airplanes listed above be modified by installing a reinforcing strap, part number 14415-00, as per the sketch below.
