VSP-30
May 20, 1981

VENDOR SERVICE PUBLICATION

Subject: Bendix Service Bulletins 599A, 609A, 610,
613, 614

SERVICE BULLETIN NO. 599A
(Supersedes Service Bulletin No. 599)
Engineering Aspects are
FAA Approved

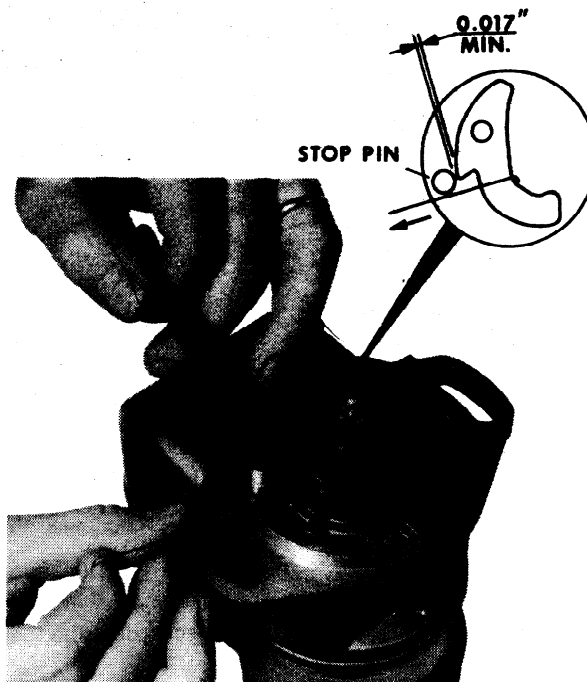
Figure 2. Checking Flyweight to Stop Pin Clearance

- a. Bend the end of a stiff wire into a right angle 1/8 inch long, maximum.
- b. Position impulse coupling so that heel of flyweight (see figure 1) is adjacent to stop pin. Reach

between cam and flyweight with bent wire, as near as possible to the stop pin, and pull outward on the flyweight as shown in figure 2.

c. While pulling flyweight outward, insert feeler gages to measure the clearance between the heel of the flyweight and the stop pin, assuring a minimum of 0.017 inch exists.

d. If less than 0.017 inch clearance exists, this is cause for immediate rejection of the impulse coupling cam assembly, or possibly the entire impulse coupling. Refer to the applicable Magneto Overhaul Instructions for inspection procedures to determine if other impulse coupling parts are still serviceable.

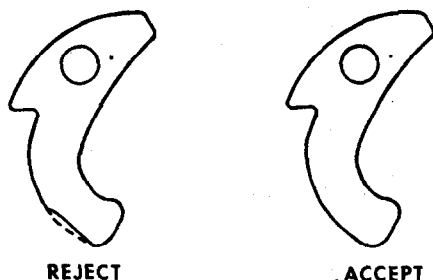
Figure 6. Flyweight Tail Condition Check

4. Flyweight tail condition must be given a visual examination to determine if flyweight is still serviceable. The surface at the apex of the beveled edge must blend smoothly with the outer contour of the flyweight. No flattening, denting or chipping is permissible. Any irregularity of this surface is cause for immediate rejection of the cam assembly. (See figure 6)

6. If the impulse coupling is found to be unacceptable as a result of any of the preceding checks described, replace the entire impulse coupling assembly or worn parts according to instructions of applicable Bendix publications.
7. When inspection of the impulse coupling assembly is being performed, the stop pins in the magneto flange or housing must also be examined. Visible damage or wear in the area where the flyweight contacts the stop pin is cause for repair or replacement of the magneto, stop pin, housing or flange depending on magneto. (Reference latest revision of Bendix Overhaul Manuals Publication Forms L-205, L-645, L-945 and L-1019.)
8. When inspection procedures outlined in this bulletin have been completed, an appropriate notation must be made in the Engine Log Book referencing magneto serial number.

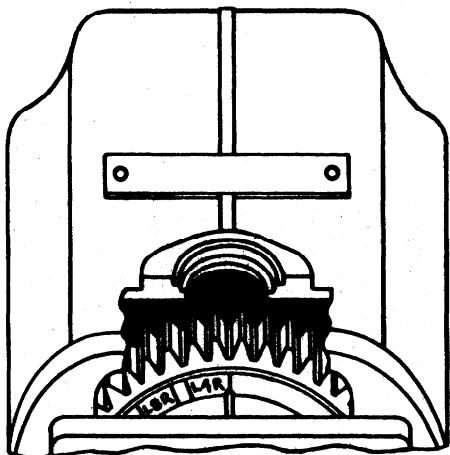
Figure 2. Alignment of Timing Marks on Distributor Gear — 4 Cylinder, Right Hand Rotation

GENERAL INFORMATION:
Field reports indicate that a quantity of remanufactured S-1200 magnetos have been discovered with the large distributor gear mistimed. To avoid damage to the distributor block and resultant ignition difficulty, the magnetos involved should be examined according to the applicable inspection method listed below.

7. If timing marks are not aligned remove magneto from engine and follow instructions in Method "B".

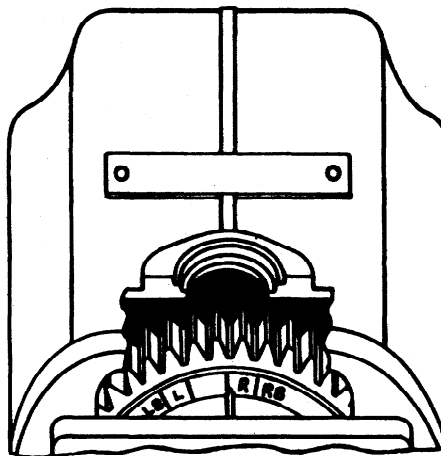
Figure 3. Alignment of Timing Marks on Distributor Gear — 6 Cylinder, Single Breaker, Right Hand Rotation

- b. "6" Cylinder, single breaker types — The timing rib on the distributor block MUST lie between the "L" and "LB" or the "R" and "RB" marks on the gear, and should be nearer to the "L" or "R" mark, depending on magneto rotation. (See figure 3)

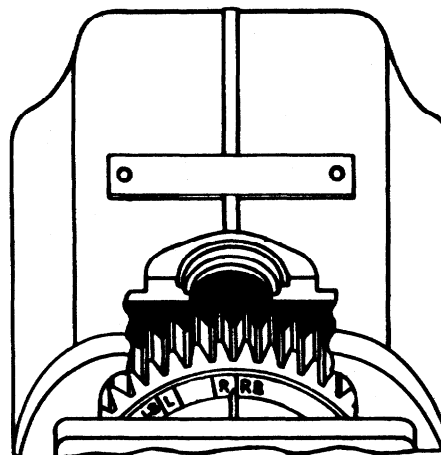
Figure 4. Alignment of Timing Mark on Distributor Gear — 6 Cylinder, Retard Breaker, Right Hand Rotation

- c. "6" Cylinder, retard breaker types — The timing rib on distributor block MUST lie between the "L" and "LB" or the "R" and "RB" marks on the gear, and should be nearer to the "LB" or "RB" mark, depending on magneto rotation. (See figure 4)

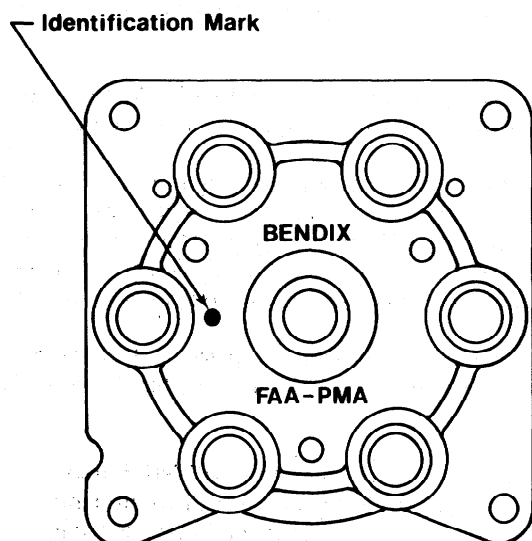
Figure 1. Location of Identification Mark

1. To announce the availability of an improved Diallyl Phthalate (DAP) green distributor block incorporating a new design "Gripper" oilite bushing.
2. To alert users of a possible loose oilite bushing in the original green DAP distributor block. Field reports indicate that the bronze oilite bushing in the current green distributor block may become loose and turn within the block. This condition could wear the block enough to cause the distributor gear to become mistimed resulting in rough engine operation.
3. To provide instructions for inspection and/or replacement of the original green distributor blocks with the new "Gripper Bushing" green distributor blocks as required.

The new "Gripper Bushing" will eliminate the possibility of the bushing becoming loose. The "Gripper Bushing" block can be identified by a circular shaped mark 0.188 inch \pm 0.031 inch in diameter raised 0.010 inch to 0.030 inch above the surface of the block. This mark is located on the tower side of the block, as indicated in figure 1.

1. All magnetos having a green distributor block with less than 1000 operating hours must have this block replaced with the new "Gripper Bushing" block within the next 25 operating hours or at the next regularly scheduled inspection, whichever occurs first.

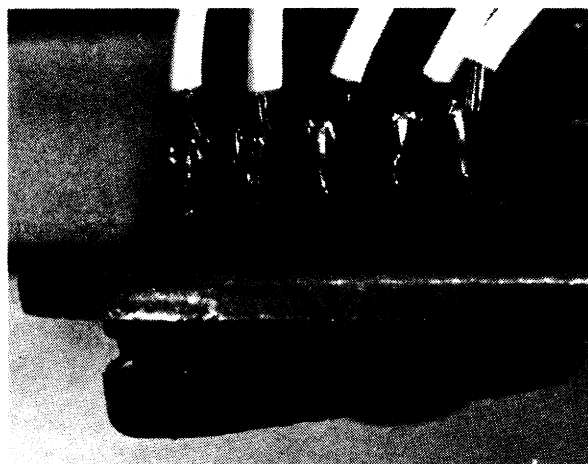
Figure 1 Defect

Bushing (connector), P/N 10-382943, may become loose in the vibrator plate and cause the grounding of both magnetos with possible loss of ignition. See figure 1 (defect).

1. Remove starting vibrator from the airframe.
2. Remove cover to expose the internal surface of the terminal bushing (connector).
3. The surface around the terminal bushing must be clean, dry, free of oil, dirt and grease.
4. Reseat the terminal bushing in the mounting plate to its full extent.
