Service Letter No. 150

July 10, 1950

SUBJECT: Bungee Cable PA-18 "105"

Serial Numbers Affected: 18-60 to 18-133 incl.; 18-135 to 18-162 incl.; 18-176 to 18-180 incl.; 18-182 to 18-196 incl.; 18-198 to 18-202 incl.; 18-205; 18-206; 18-209; 18-210; 18-212 to 18-217 incl.; 18-219 to 18-221 incl.; 18-224 to 18-226 incl.; 18-228; 18-229; 18-231 to 18-233 incl.

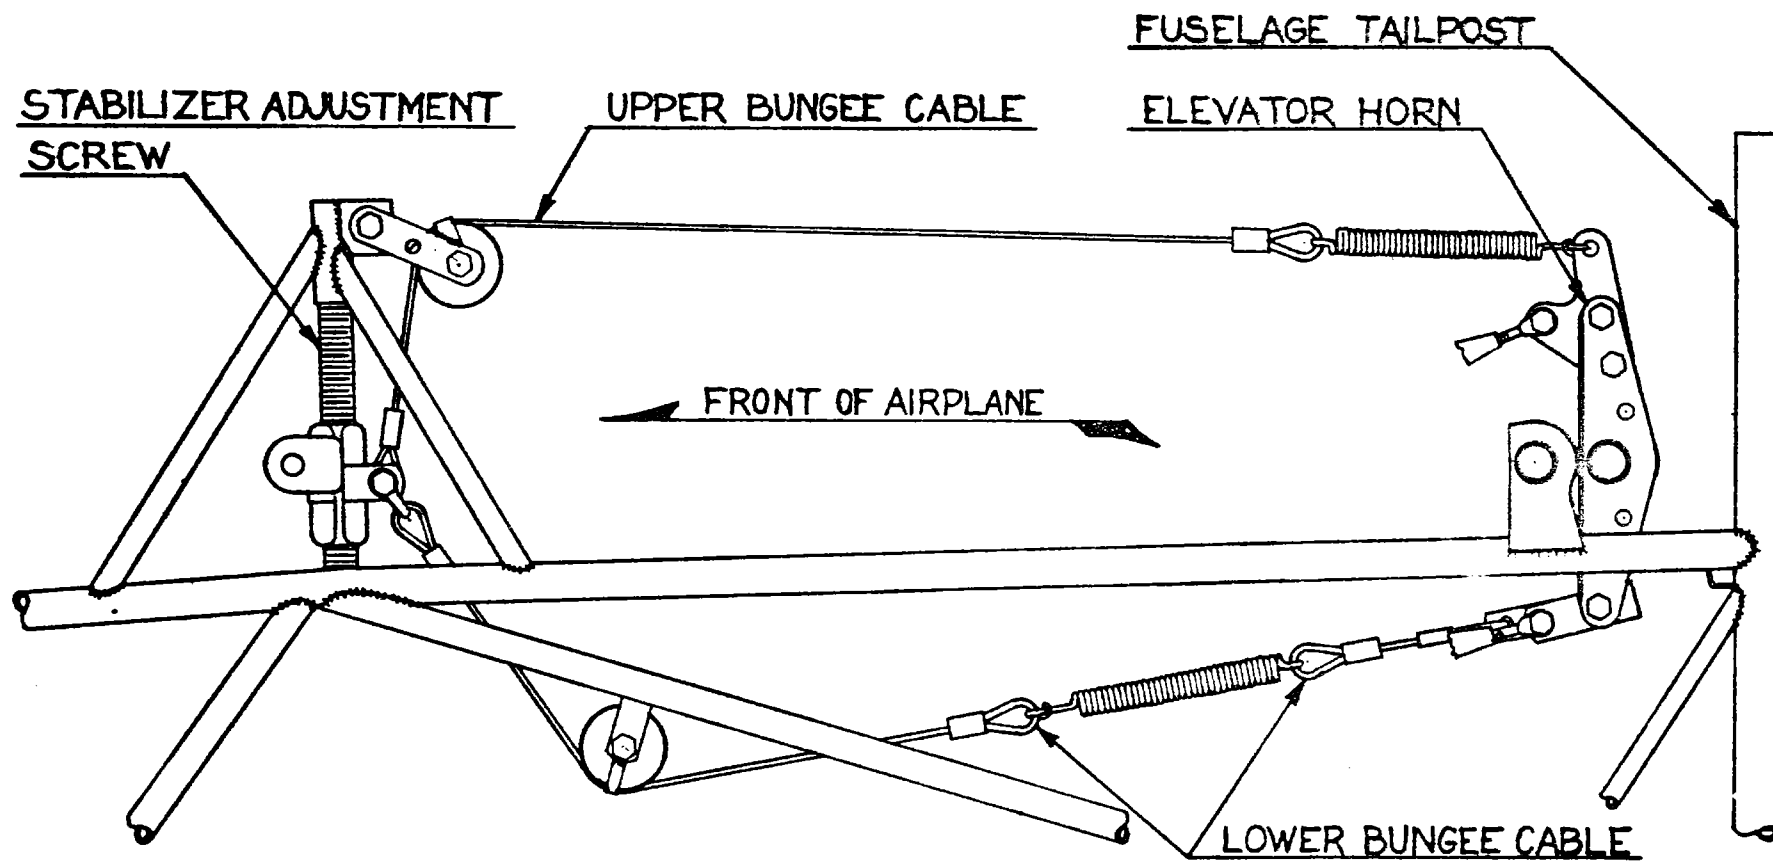
BUNGEE INSTALLATION
MODEL PA-18 "105"

In view of the many comments which we have received from the field, relative to the extremely stiff elevator action on the PA-18 "105" our Engineering Department has issued approval to remove the lower bungee cable, as indicated in the sketch on the reverse side of this letter.

After removal of the lower bungee cable, the proper entry should be made in your log book.
