Service Letter No. 212

Subject: Nose Wheel Shimmy Dampener, Part No. 13086-00

Models Affected: All 1953 Model PA-22's with serial numbers 22-807 to 22-1614 inclusive, 22-1616 to 22-1631 inclusive, 22-1633 to 22-1635 inclusive, 22-1638, 22-1642, 22-1646 to 22-1648 inclusive, 22-1651, 22-1653, 22-1655, 22-1656, 22-1658 to 22-1661 inclusive, 22-1666, 23-1667, 22-1672, 22-1678, 22-1680, 22-1682 and 22-1683.

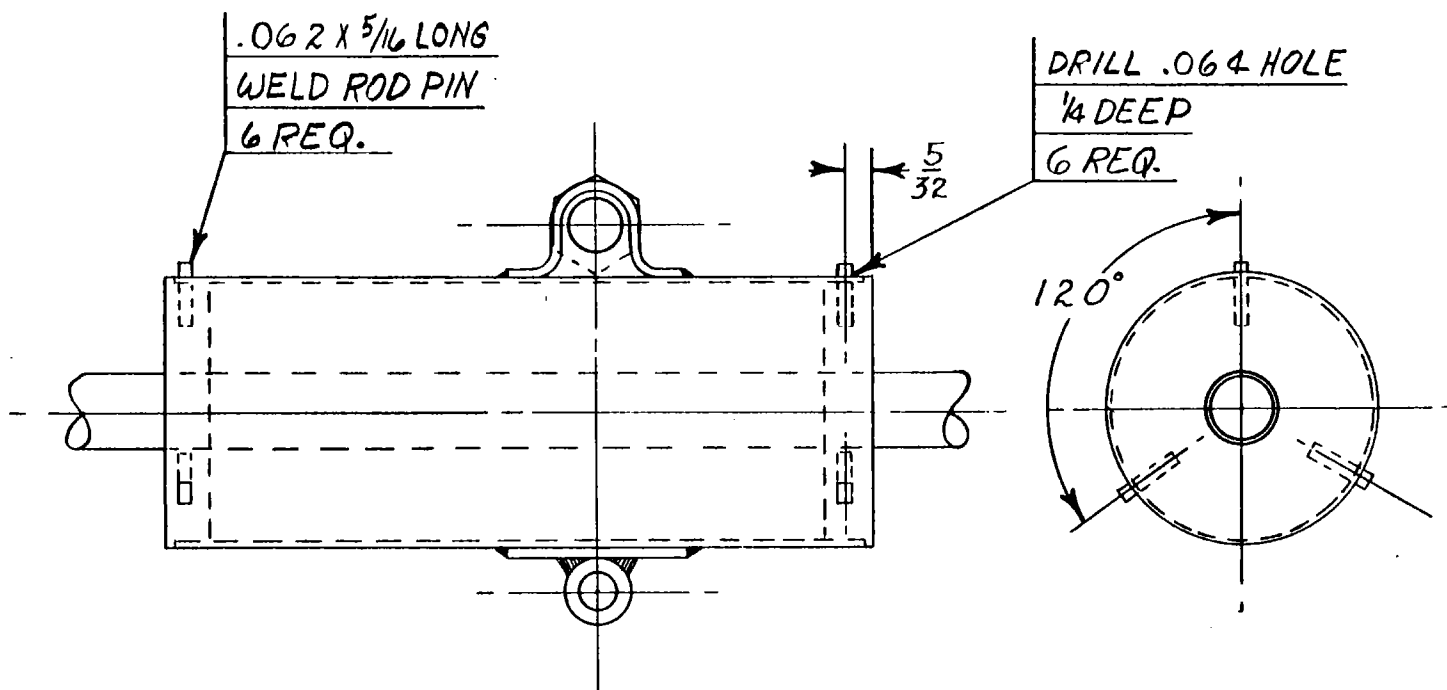
During the past few months we have received from the field a number of shimmy dampeners, part number 13086-00, on which a separation has occurred between the assembly body and the end plate. This separation was due to solder breaking loose and the internal fluid pressure plus the friction of the plunger forcing the end plate outward.

All production airplanes have been modified in accordance with the sketch shown on the reverse side of this Letter and it is felt that this modification can be satisfactorily executed in the field as a service-fix. Upon inspection if the shimmy dampener shows signs of separation, it will be exchanged free-of-charge at the nearest Piper Distributor or Dealer.

DRIVE PIN INTO EACH HOLE AND SOLDER END, COVERING
PIN WITH SOLDER.
