## VENDOR SERVICE PUBLICATION

SUBJECT: AVCO Lycoming Service Bulletin No. 464A

<b>Bendix Engine Products Division</b> Jacksonville, FL. 32245-7880
<b>SERVICE BULLETIN</b> JP- 00278	
Engineering Aspects are FAA Approved	
Bulletin No. 623A	
Date 9/1982	
Revised 8/1984

Inspection of impulse coupling cam assemblies.

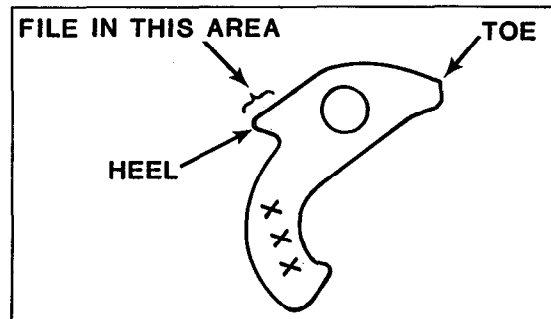
Figure 1.

Some improperly heat treated (soft) flyweights have been reported on impulse couplings currently in service. If this condition exists and is not detected, impulse coupling failure could occur. The flyweights must be inspected in accordance with the instructions in this Service Bulletin and if defective (soft) the impulse coupling or cam assembly must be replaced immediately.

3. Use finger pressure to push inward on the toe (see figure 1) of each flyweight so that the flyweight heel protrudes outward.
4. Using a fine #1, double cut, 1/2 inch wide file, at least 3/32 inch thick, pass the file across the heel of the flyweight attempting to remove material. (See figure 1.) If the flyweight has been properly heat treated the file will "glide" smoothly over the heel of the flyweight, removing no material. If the flyweight is not properly heat treated (soft), the file will not "glide" easily across the surface of the flyweight heel, and material will be removed.

XXX indicates heat treated flyweight by lot number

5. If an improperly heat treated (soft) flyweight is found, immediately remove and replace the cam assembly and/or the impulse coupling assembly following procedures in the magneto overhaul instructions, and paying strict attention to notes and cautions.

11. Any cam assembly with an improperly heat treated (soft) flyweight should be returned to the manufacturer through a currently Authorized Bendix Engine Products Division Distributor.
12. A new method of marking is being implemented to permanently identify heat treated cam assembly flyweights. See figure "1" for location. Pending consumption of current inventory, there will be a mixture of assemblies identified by the following methods.
  1. Original method ---- Yellow paint (Dykem or Lacquer) on the heel of each flyweight.
  2. New method ---- Stamped numbers as indicated in figure "1" on each flyweight.
