LETTER

Service Letter No. 485

Scott Aviation Corporation Modification Instructions I-298 for Mask Assembly - Constant Flow (Semi-Disposable) Scott Part Number 28302

MODIFICATION INSTRUCTIONS FOR MASK ASSEMBLY—CONSTANT FLOW

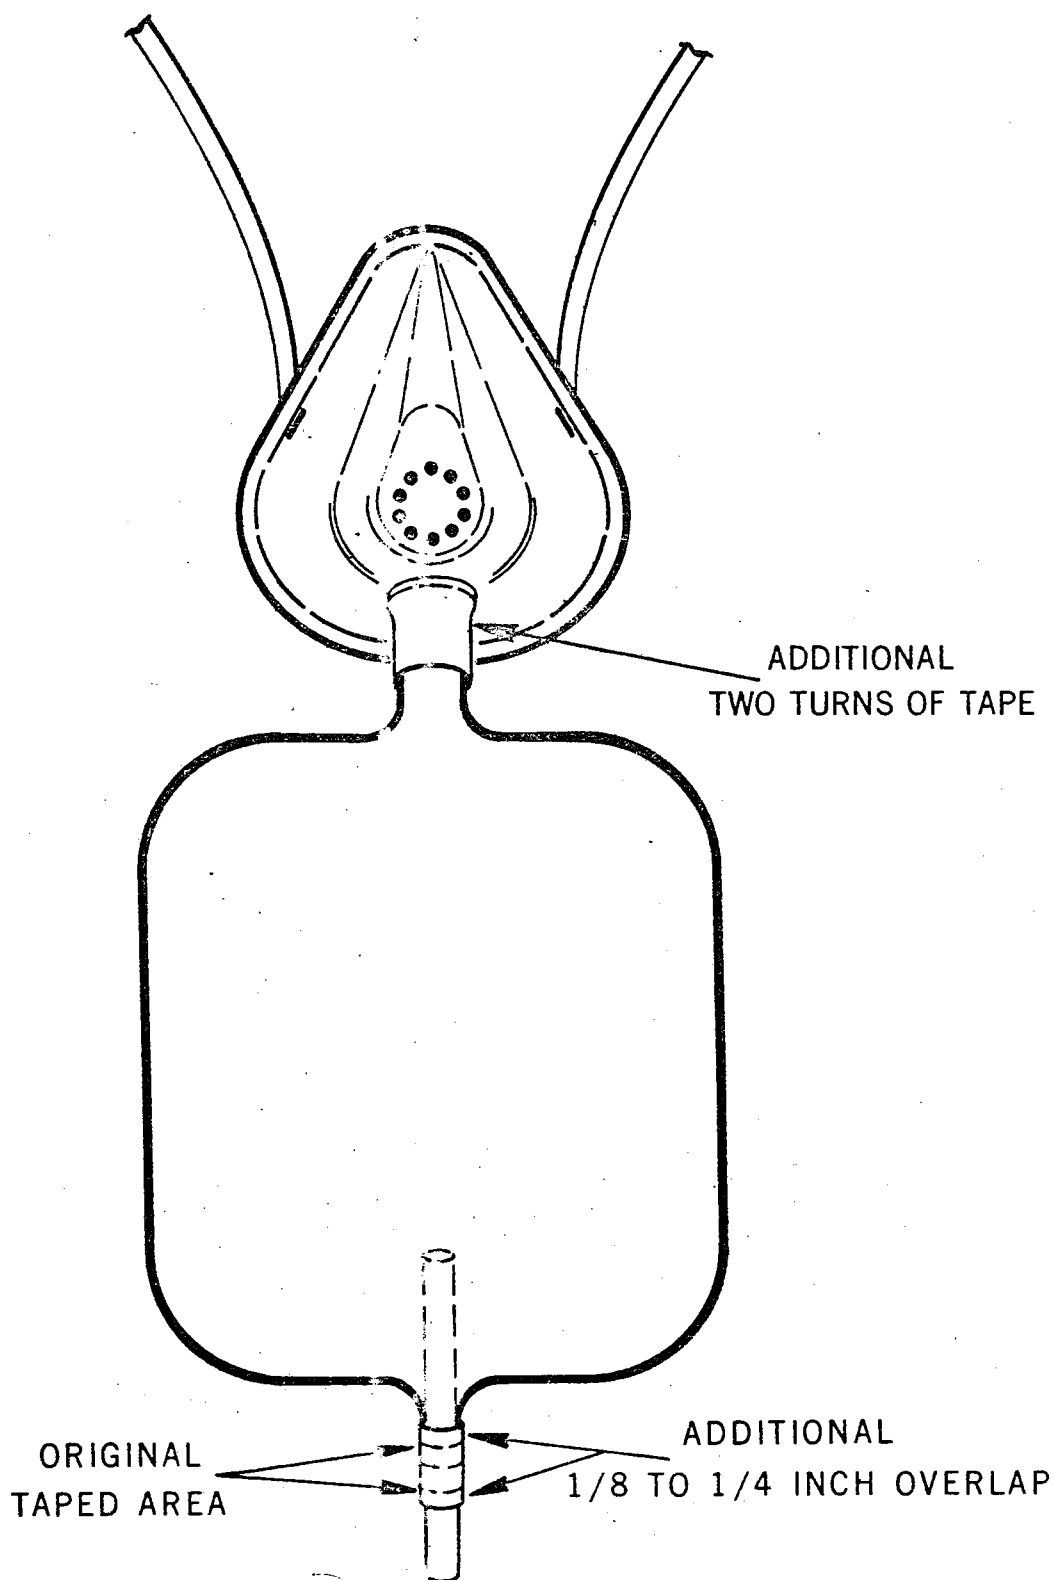
FIGURE 1

To ensure that the rebreather bag will not separate from either the bag tube or face mask during usage, due to inadequate adhesion of original tape used.

- A. Visually inspect condition of existing tape. If torn or wrinkled, remove tape (see figure 1).
- B. Reposition bag tube (if necessary) so that approximately 1/3 of bag tube protrudes out of rebreather bag.
- C. Apply three to four complete turns of tape (equally spaced over connection), and ensure good contact by tightly stretching tape during application.

The over-tape or new tape must contact the rebreather bag and bag tube, and extend at least 1/8 to 1/4 inch beyond the edges of the original tape.

- D. Apply two additional complete turns of tape (mask to rebreather connection), and ensure good contact by tightly stretching tape during application.
