SERVICE BULLETIN

No. 324

Piper Aircraft Corporation

Vacuum Pump Adapter Drive Assembly

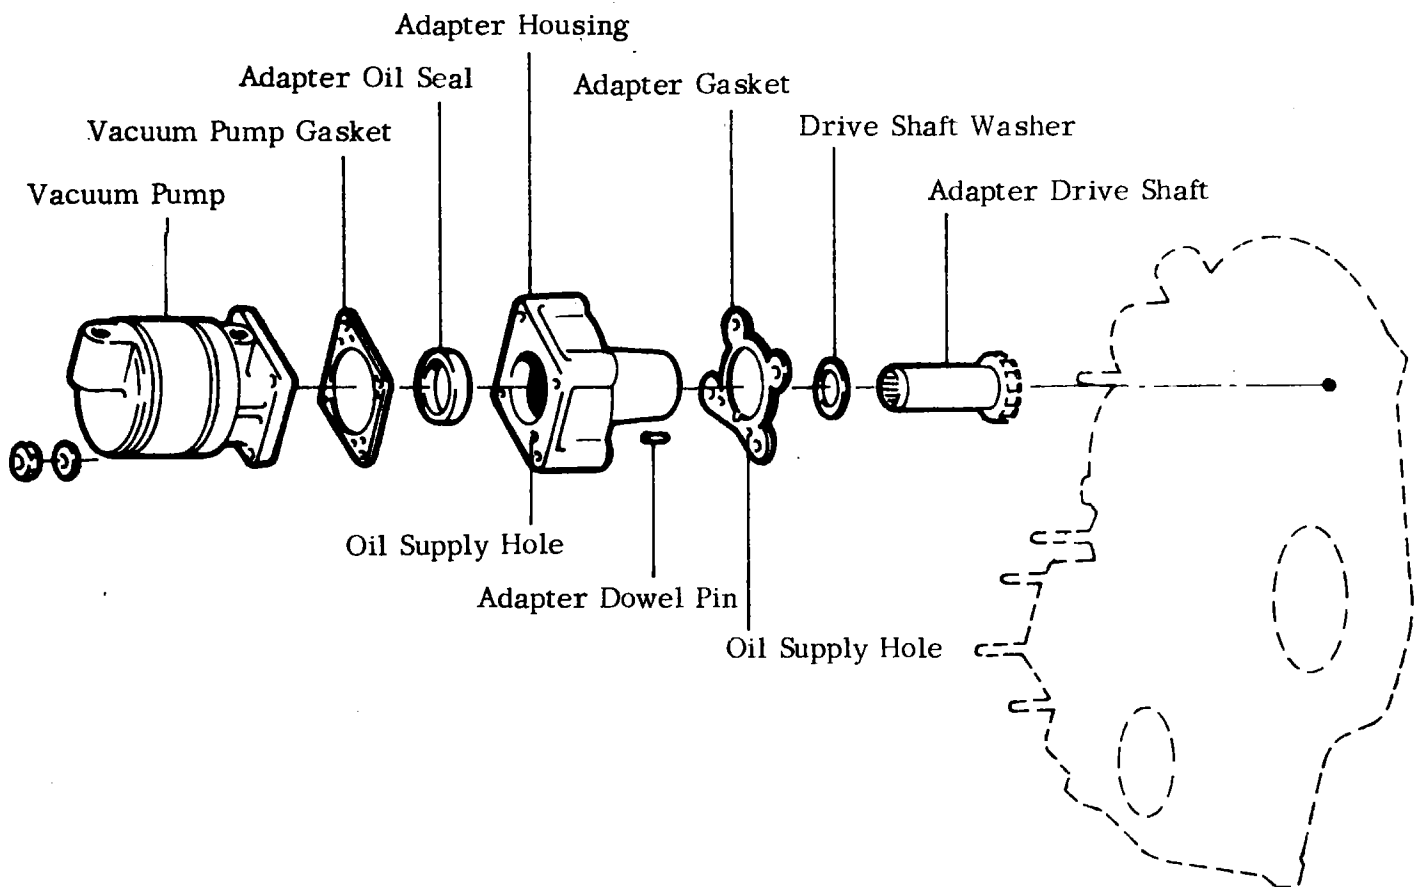
To provide instructions for an inspection of the vacuum pump adapter drive assembly (reference attached sketch for an illustration of the area to be inspected).

- I. Remove vacuum pump and vacuum pump adapter assembly from engine.
- II. Remove drive shaft from adapter housing and inspect the shaft for any sign of aluminum pick up on shaft at either end of shaft where it contacts adapter bearing bore.
- III. Inspect the adapter housing for the following:
 - a. Any evidence of inadequate lubrication resulting from foreign chips in oil supply hole.
 - b. Omission of oil supply hole.
 - c. Improper location of dowel.
 - d. Improper indexing of drive adapter assembly to accessory pad.
- IV. Inspect gasket, Lycoming part number 61183, for omission of oil transfer hole.

IF ANY DISCREPANCIES ARE FOUND, DO NOT ATTEMPT TO REPAIR. Contact your local Lycoming Regional Representative or Lycoming Service Department for further instructions.

- V. If the above referenced inspection procedure discloses no discrepancies, clean and lubricate (with SAE 50 oil) all parts that were inspected and reinstall on engine; torque all nuts to 50 to 70 inch pounds.
