Why you Should Know your ECU; Three Case Studies

Why you should know your ECU; Three case studies.

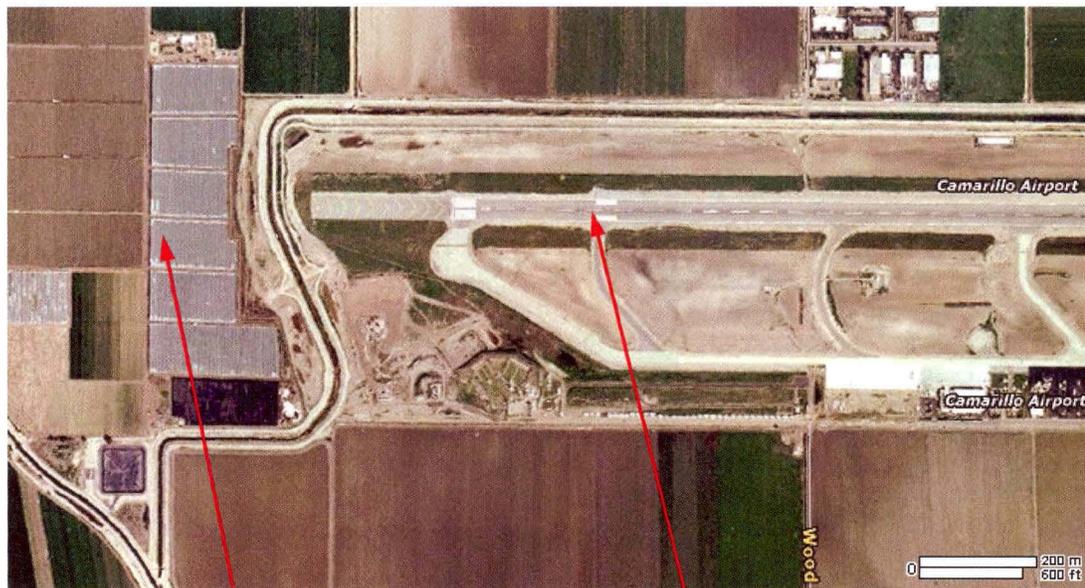
Crash site

Limp-home mode started here

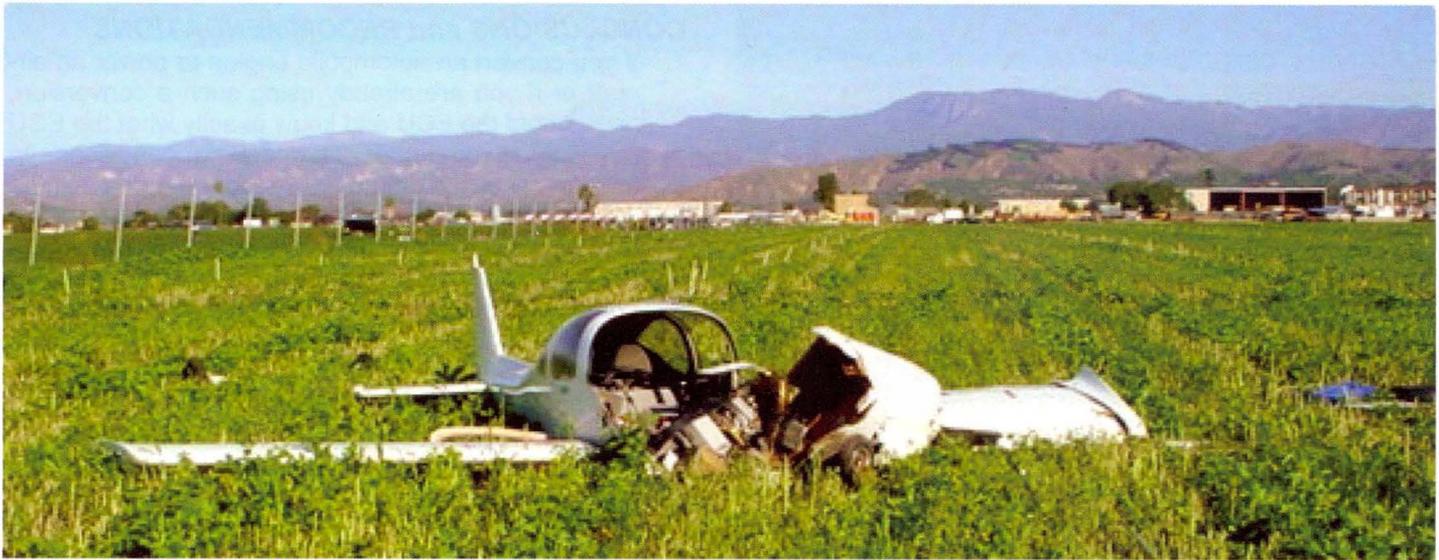
N506RJ after its second flight, at rest in the celery field adjacent to the airport.
