VENDOR SERVICE PUBLICATION

SUBJECT: Goodyear Aerospace Service Bulletin No. FT-77-1 Rev. B dated August 31, 1977; Recommended inspection of (Goodyear) fuel tanks, etc.

SERVICE BULLETIN

SUBJECT: FUEL SYSTEMS - RECOMMENDED INSPECTION FOR POSSIBLE FUEL SEEPAGE FROM RUBBER-TYPE FUEL TANKS INCLUDING INSPECTION FOR POSSIBLE DETERIORATED OR SOFT RUBBER NIPPLE FITTINGS.

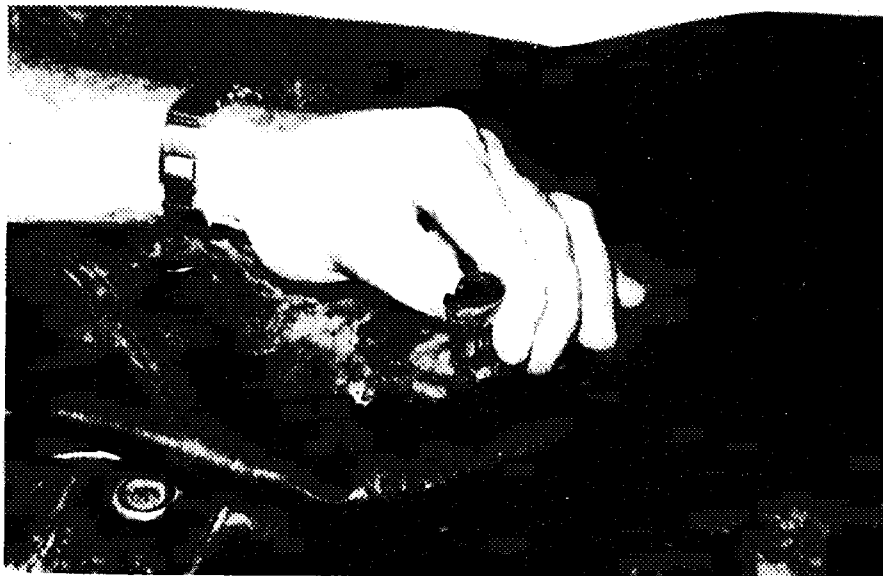
FIGURE 1

The fingernail test consists of using the fingernail to attempt to scrape the rubber off the nipple fitting (see Figure 1). If the rubber has not degraded, the fingernail will glide across the rubber without damage to the rubber. If an unsatisfactory condition exists, the fingernail will dig into the rubber. The rubber will have a consistency of either art gum or chewing gum. Usually the deteriorated rubber will have changed from a light tan color to a dark reddish-brown or greenish color depending upon color of fuel used.

5. Any fuel tank found seeping or with soft nipples should be replaced.
6. Reinstall fuel tank, fuel system and access plate and functionally check the fuel system.
