VSP-30
May 20, 1981

VENDOR SERVICE PUBLICATION

Subject: Bendix Service Bulletins 599A, 609A, 610,
613, 614

SERVICE BULLETIN NO. 599A
(Supersedes Service Bulletin No. 599)
Engineering Aspects are
FAA Approved

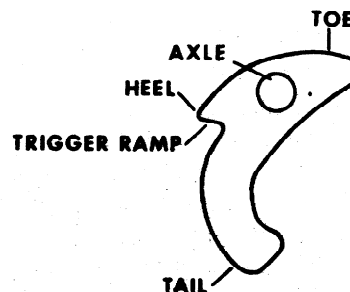
Figure 1. Terminology

- a. Bend the end of a stiff wire into a right angle 1/8 inch long, maximum.
- b. Position impulse coupling so that heel of flyweight (see figure 1) is adjacent to stop pin. Reach

between cam and flyweight with bent wire, as near as possible to the stop pin, and pull outward on the flyweight as shown in figure 2.

d. If less than 0.017 inch clearance exists, this is cause for immediate rejection of the impulse coupling cam assembly, or possibly the entire impulse coupling. Refer to the applicable Magneto Overhaul Instructions for inspection procedures to determine if other impulse coupling parts are still serviceable.

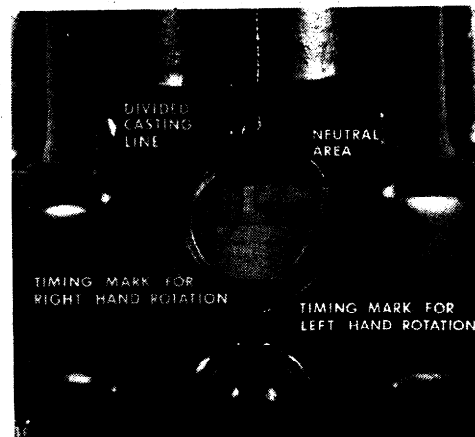
Figure 1. Alignment of Magnet Marks —
Right Hand Rotation

- a. Turn engine in direction of normal rotation toward the firing position of No. 1 cylinder on the compression stroke. As this point is approached the timing ribs or marks on the rotating magnet should begin to appear in the open viewing hole.
- b. Continue turning the engine slowly, still in the direction of normal rotation, until the proper timing mark on the rotating magnet is centered in the viewing hole. Figure 1 illustrates the timing mark centered for a right hand rotation magneto. A left hand rotation magneto would have the left hand mark centered. Eight cylinder magnetos will show an "R" line or an "L" line on the rotating magnet through the viewing hole.

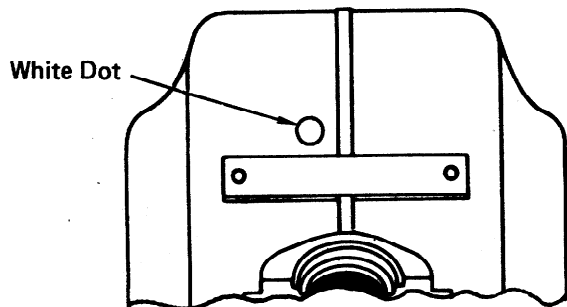
Figure 5. Typical identification mark location.

- a. An appropriate Engine Log Book entry must be made.
- b. The magneto must be identified by painting a white dot approximately 1/4 inch in diameter on the magneto housing at the location indicated in figure 5.

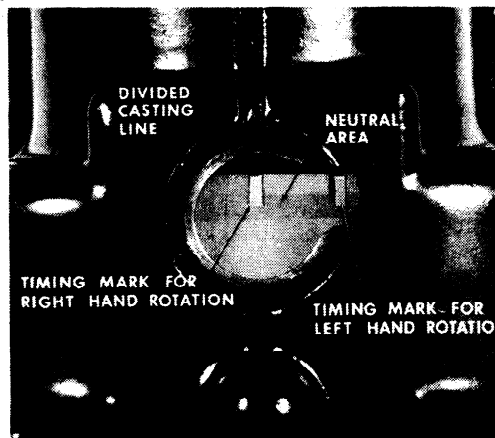
Figure 2. Alignment of Magnet Marks —
Right Hand Rotation

- b. Continue turning the engine slowly, still in the direction of normal rotation, until the proper timing mark on the rotating magnet is centered in the viewing hole. Figure 2 illustrates the timing mark centered for a right hand rotation magneto. A left hand rotation magneto would have the left hand mark centered. (See figure 2.) Eight cylinder magnetos will show an "R" line or an "L" line on the rotating magnet.

one cylinder firing position until proper timing mark on rotating magnet is in the center of the viewing hole. (See figure 2.)

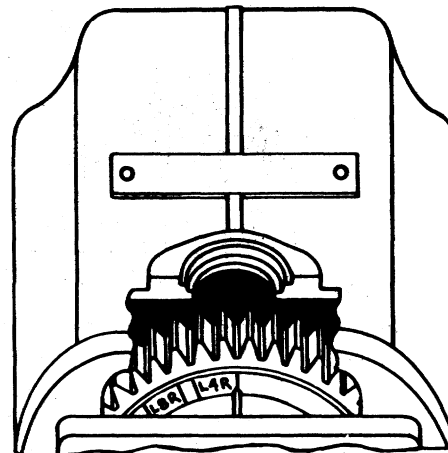
Figure 3. Alignment of Timing Marks on Distributor
Gear — 4 Cylinder, Right Hand Rotation

6. Check at top timing hole in magneto to determine if the proper mark on the distributor gear aligns with the timing rib on the distributor block. Alignment tolerances are as follows:
 - a. Four and eight cylinder, all types — The timing rib on the distributor block **MUST** align within 1/2 tooth either side of the "L" or "R" mark on the gear, depending on magneto rotation. (See figure 3.)

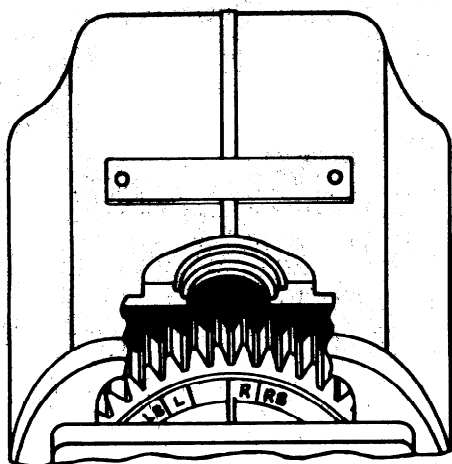
**Figure 4. Alignment of Timing Marks on Distributor Gear —
6 Cylinder, Single Breaker, Right Hand Rotation**

b. Six cylinder, single breaker types — The timing rib on the distributor block **MUST** lie between the "L" and "LB" or the "R" and "RB" marks on the gear, and should be nearer to the "L" or "R" mark, depending on magneto rotation. See figure 4.

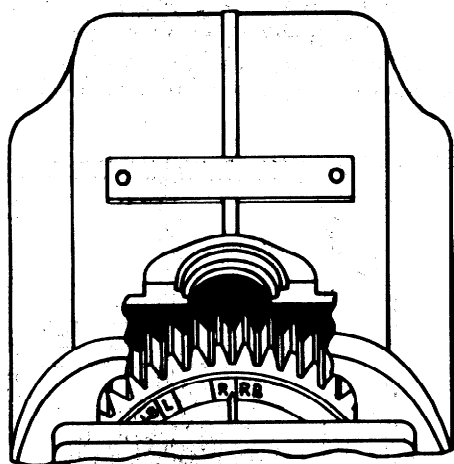
**Figure 5. Alignment of Timing Marks on Distributor Gear —
6 Cylinder, Retard Breaker, Right Hand Rotation**

c. Six cylinder, retard breaker types — The timing rib on the distributor block **MUST** lie between the "L" and "LB" or the "R" and "RB" marks on the gear, and should be nearer to the "LB" or "RB" mark, depending on magneto rotation. (See figure 5.)
