Why you Should Know your ECU; Three Case Studies

Why you should know your ECU; Three case studies.

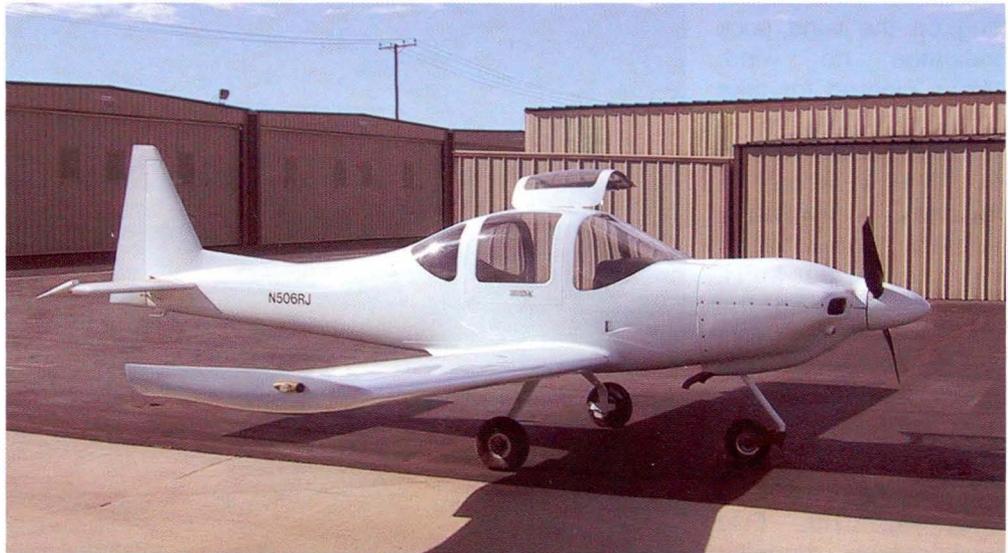
N506RJ before its first flight on January 3, 2006

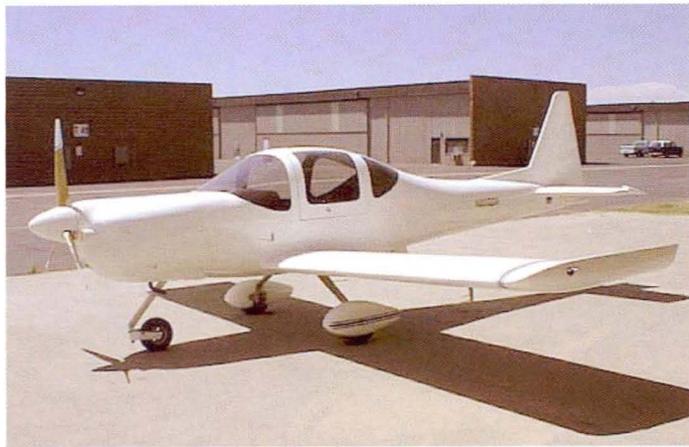
All indications are that the OEM ECU sensed some condition that it was programmed to believe was catastrophic for the engine and shut it down to "limp home" mode. In an automobile, this is a very handy feature since it allows you to limp home at 20-25 MPH so you can get it fixed, but not so good for an airplane.

It appeared that when the engine was run at full throttle for some predetermined length of time (in my case it appeared to be about a minute at about 4,600 RPM), the ECU reduced the power down to about 2,200. Probably the reason it didn't happen during the first flight was I was only using partial throttle. The previous occurrence of limp home (in Michigan) happened at altitude after the pilot completed his climb and started a high speed test run (see case study 1 for details).
Larry David

1. If you convert an automobile engine to power an aircraft or if you are already using such a conversion, learn about the ECU and know exactly what the ECU is going to do under all operating conditions. In Larry's case, maximum power for about a minute resulted in a broken plane. Thorough testing like Graham is doing would have prevented this outcome. Modifying the tach signal such as George has done would also have prevented the problem.
